# TEST REPORT

Report No.: SHE23070128-01CE

Sample Name : IMU/VRU/AHRS Module

Test item(s) : IP68.

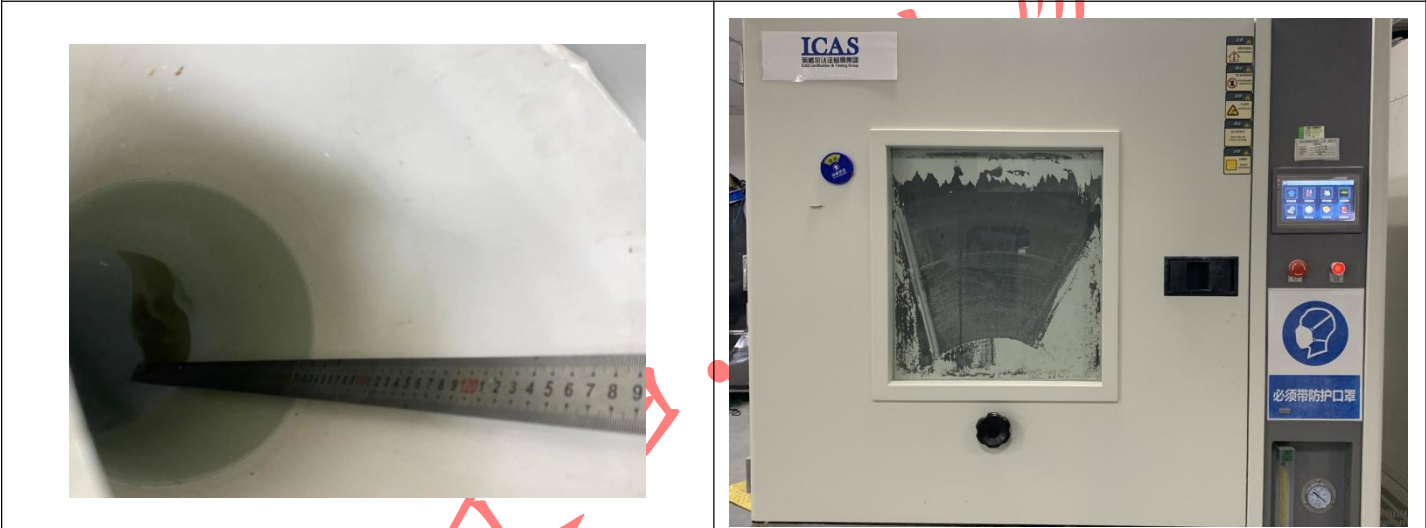
IPX7 during test

IP6X during test

Test items	Test Method	Test conditions	Test Results	Limited Value	Item(s) Conclusion
IP6X	IEC 60529-2013	Floating dust 8h, Internal negative pressure, After the test, check whether there is dust inside the sample.	After the test, there is no dust inside the tested area of the sample	No dust ingress	Pass
IPX8	IEC 60529-2013	The sample was immersed in water, and the bottom of the sample is at least 1 m below the water surface, and the test duration is 35 minutes.	After test, There is no water in the sample.	There is no water in the sample.	Pass
